FIRE EXPOSURE TESTS OF POLYETHYLENE AND FIFTY-FIVE AND STEEL DRUMS LOADED WITH FLAMMABLE LIQUIDS PHASE II

R. C. Richards and G. J. Munkenbeck, Jr. U.S. Coast Guard Research and Development Center Avery Point, Groton, Connecticut 06340

August 1977

Final Report

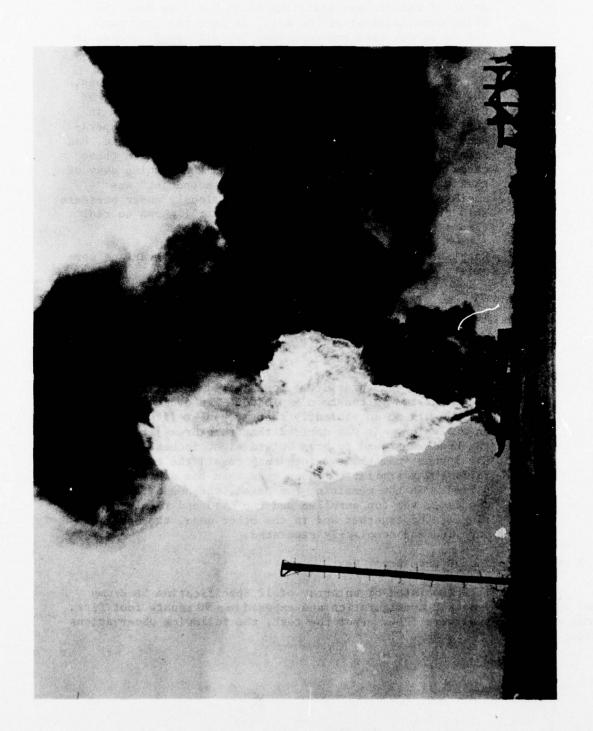
FIGURE 6

JETTING FAILURE OF ETHYL OF ETHER IN A SPECIFICATION 5B DRUM EXPOSED TO A 90 SQUARE FOOT FIRE

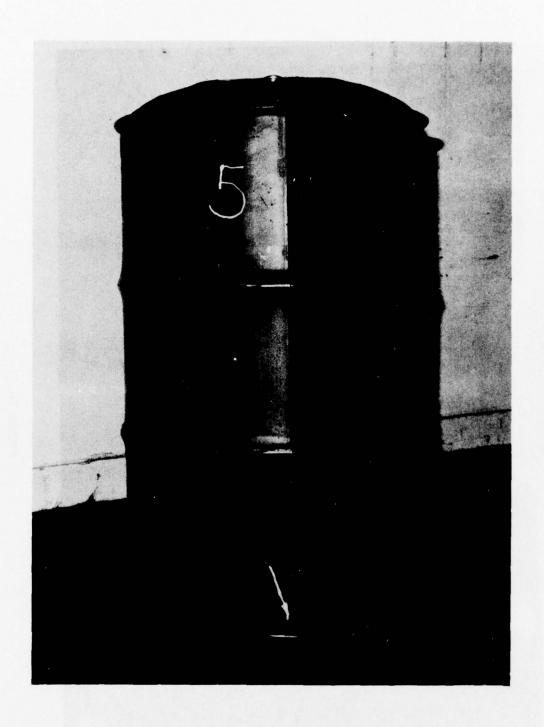
FIGURE 9
POINT OF FAILURE OF A SPECIFICATION 5B DRUM DURING HYDROSTATIC TESTS

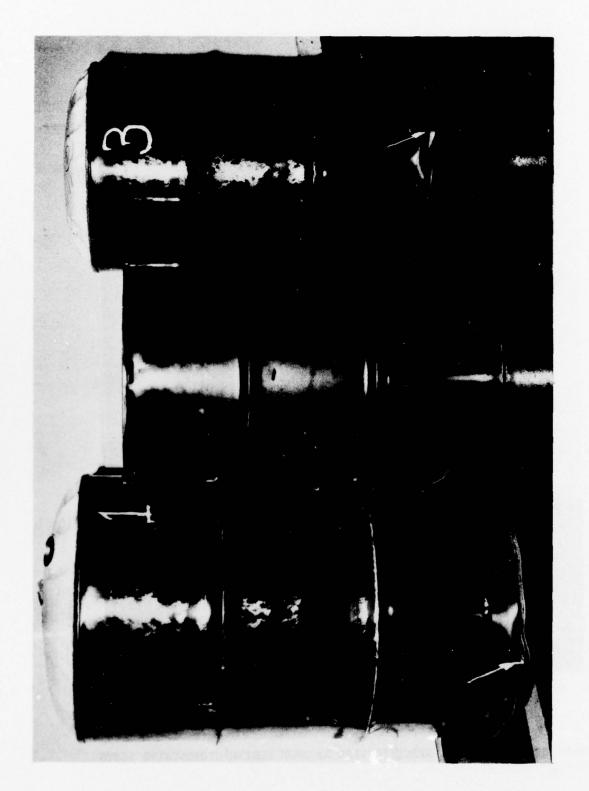
FIGURE 10

A SPECIFICATION 17E DRUM COMPARED TO TWO WHICH FAILED DURING HYDROSTATIC TESTS

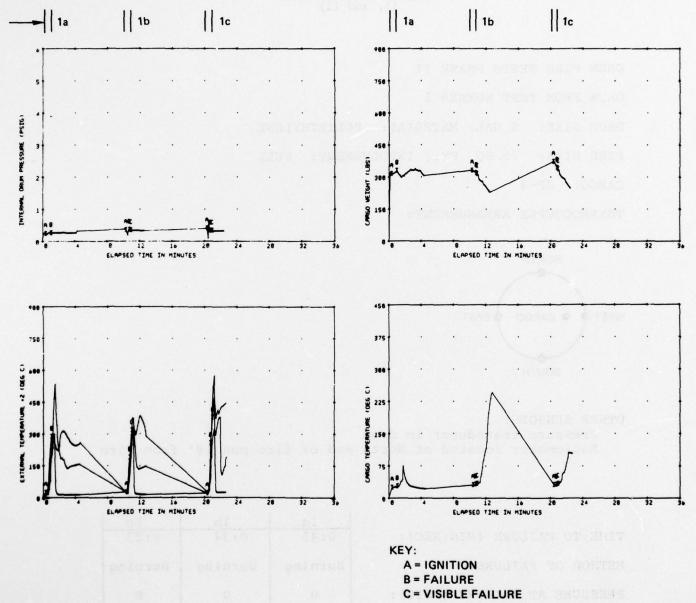
la	1b	lc
TIME TO FAILURE (MIN:SEC):	0:45	0:34	0:23
METHOD OF FAILURE:	Burning	Burning	Burning
PRESSURE AT FAILURE (PSIG):	0	0	0

North thermocouple went open after 3 min.

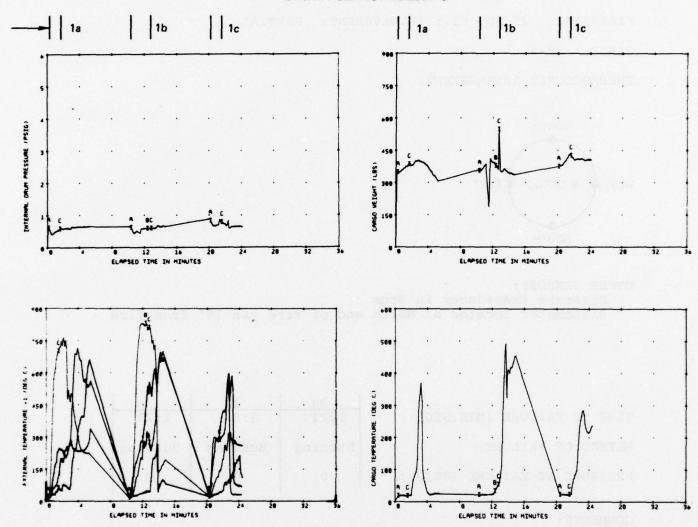
3a) Visible failure - instruments did not record failure until 2'36". Drum failed with small leak and there was no radical weight loss.

3b) Drum slowly collapsed into the fire.

3c) Visible failure - weight loss very slow.

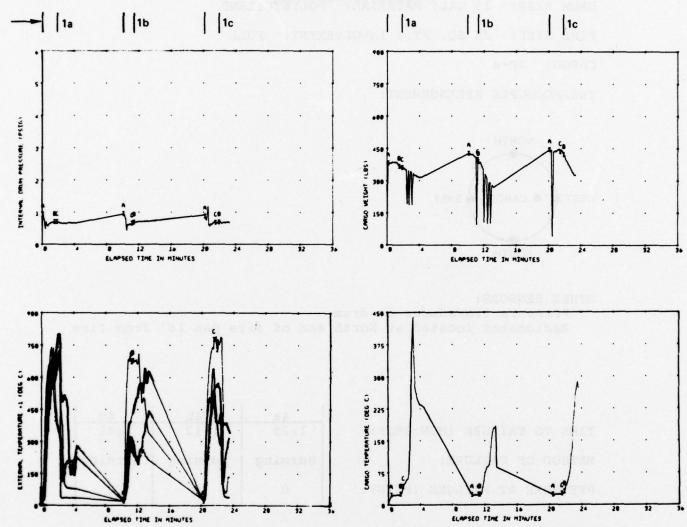
4a	4b	4c
TIME TO FAILURE (MIN:SEC):	1:25	1:12	1:41
METHOD OF FAILURE:	Burning	Burning	Burning
PRESSURE AT FAILURE (PSIG):	0	0	0

- 4b) Visible failure at 1:07.
- 4c) Visible failure at 1:17.

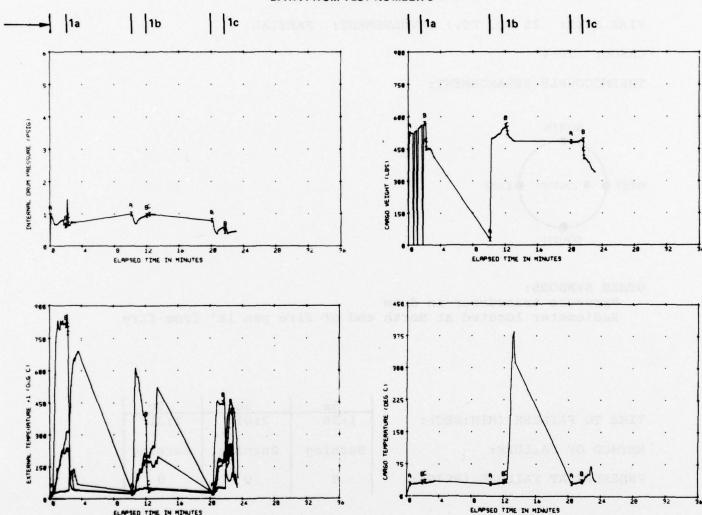
5a	5b	5c
TIME TO FAILURE (MIN:SEC):	1:56	2:01	1:31
METHOD OF FAILURE:	Burning	Burning	Burning
PRESSURE AT FAILURE (PSIG):	0	0	0

5a) Slight pressure drop shows that failure may have occurred
10 to 20 seconds earlier. Drum folded slowly into fire.
5c) Drum fell over due to bottom third softening.

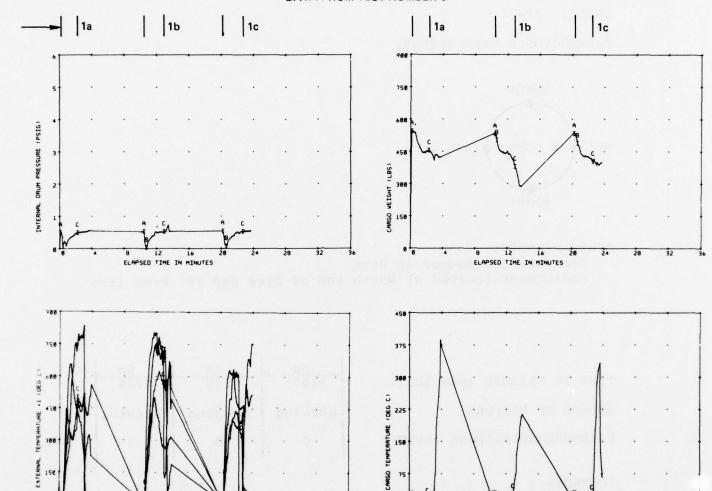
6a) Visible failure. Appreared to be a weight loss at 40 seconds. Drum failed on East side. Fire eddys noted under rolling drums.

6b) Drum failed on West side on bottom third.

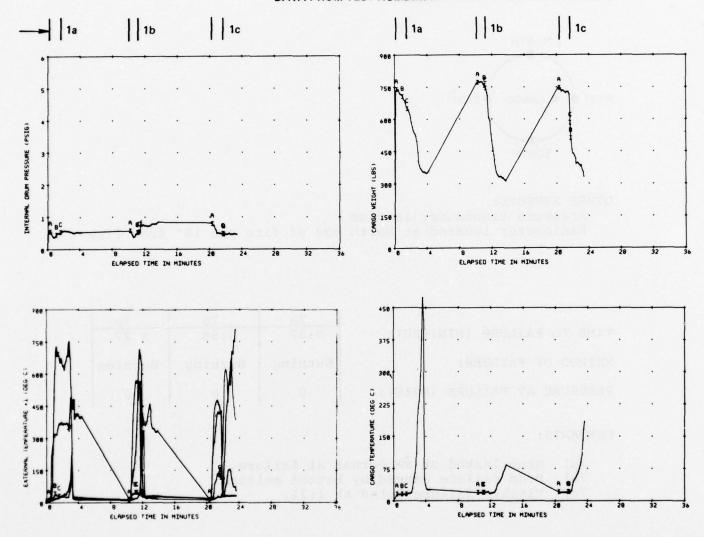
7a) Drum leaked at SW corner at failure.

7b) Drum failure caused by bottom melting.

7c) Visible failure noted at 1:21.

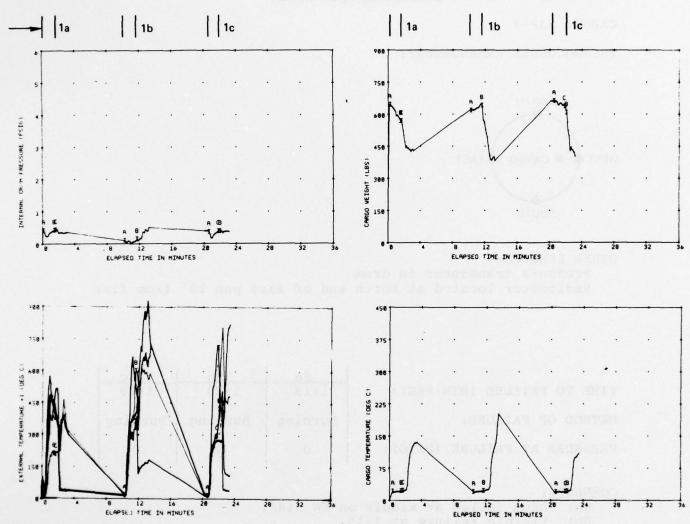
8a) Drum failed at middle on SW side.

8b) Visible failure at 1:15.

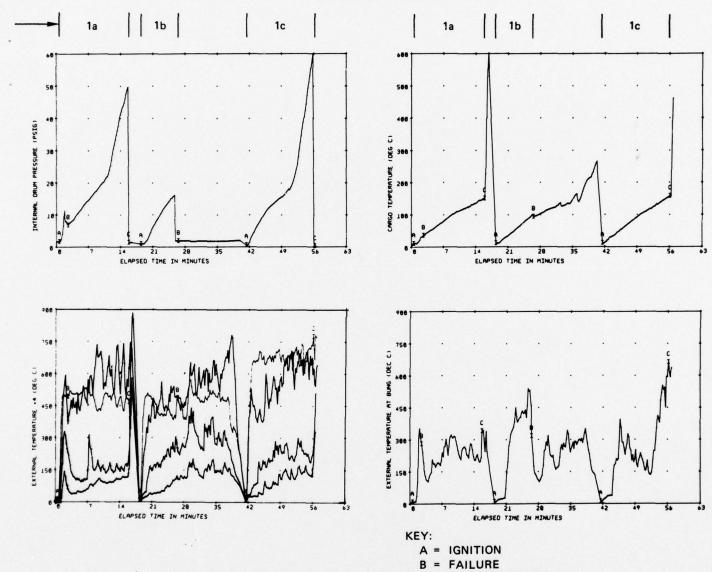
2. BOTTOM SEAM FAILED BY TEARING

AT INSIDE EXTERIOR SEAM-ONLY 1 FOOT REMAINED IN TACT

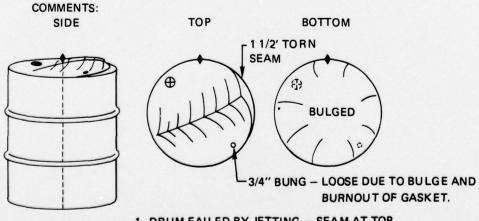
METHOD OF FAILURE: JETTING EXPLOSION

TIME TO FAILURE (MIN:SEC): 5.53
PRESSURE AT FAILURE (PSIG): 16.8 -

1. DRUM FAILED BY JETTING — SEAM AT TOP
WAS TORN AT INSIDE EXTERIOR FOR 1 1/2 FOOT

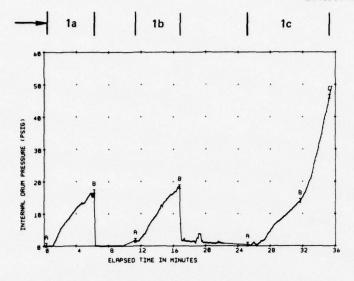
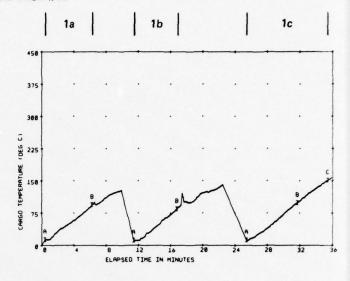
DATA FROM TEST #12

- 1. VERY SMALL JETS FOLLOWE D BY BOTTOM FAILURE WHICH WAS CAUSED BY SEAM UNROLLING. BOTTOM COMPLETE LY REMOVED.
- 2. EXPLOSION VIOLENT CAGE DAMAGED SW LEG WELD BROKEN OFF. CARCO WAS THROWN INTO THE AIR AS A FIRE BALL. DRUM AND FIRE BALL HEIGHT RESTRICTED BY CAGE.

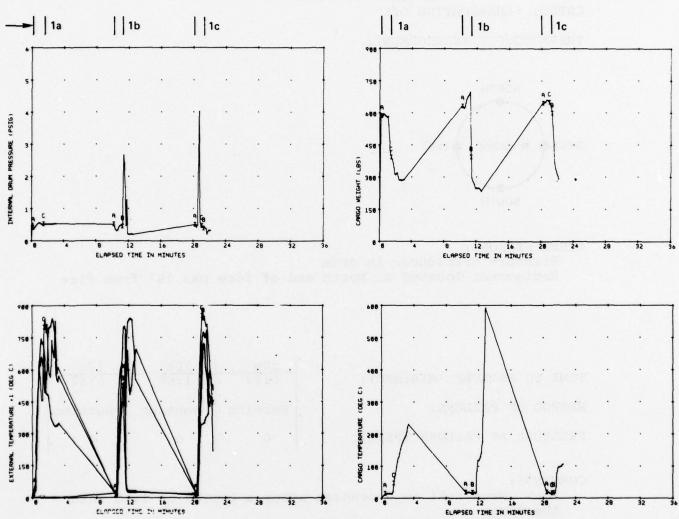
DATA FROM TEST NUMBER 10

10a) Drum fell to Southeast after a period of 1:15 into the fire.

10c) Drum collapsed into fire after 0:52 exposure.

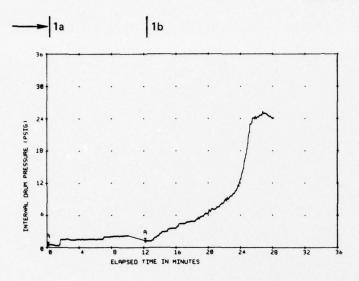
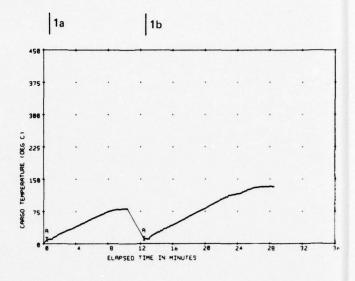
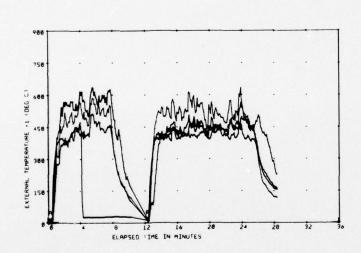
DATA FROM TEST #13

- 1. FIRE BURNED OUT AT 16:00
- 2. BOTTOM AND HEAD BULGED 2". EVIDENCE THAT UNROLLING HAD STARTED.

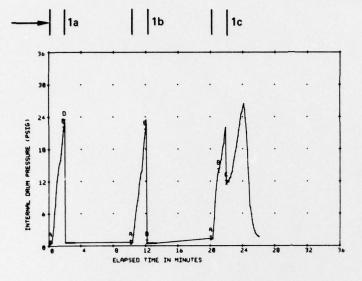
DATA FROM TEST #17

1. DRUM JETTED, PRESSURE WENT DOWN, THEN INCREASED AND STARTED SECOND MORE VIOLENT JET

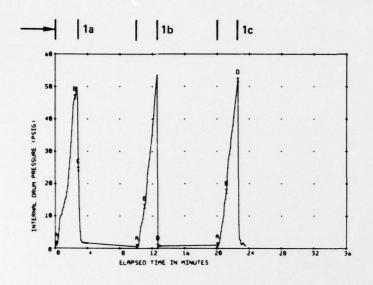
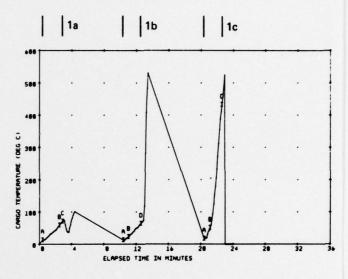
DATA FROM TEST #18

METHOD OF FAILURE: TIME TO FAILURE (MIN:SEC): PRESSURE AT FAILURE (PSIG):	JETTING 0:57 15.3	EXPLOSION 2:23 52.0
---	-------------------------	---------------------------
